Pioneer Record

Catastrophic Canal Break Put Eagle Harbor Under Water

Vol. 3, No. 30

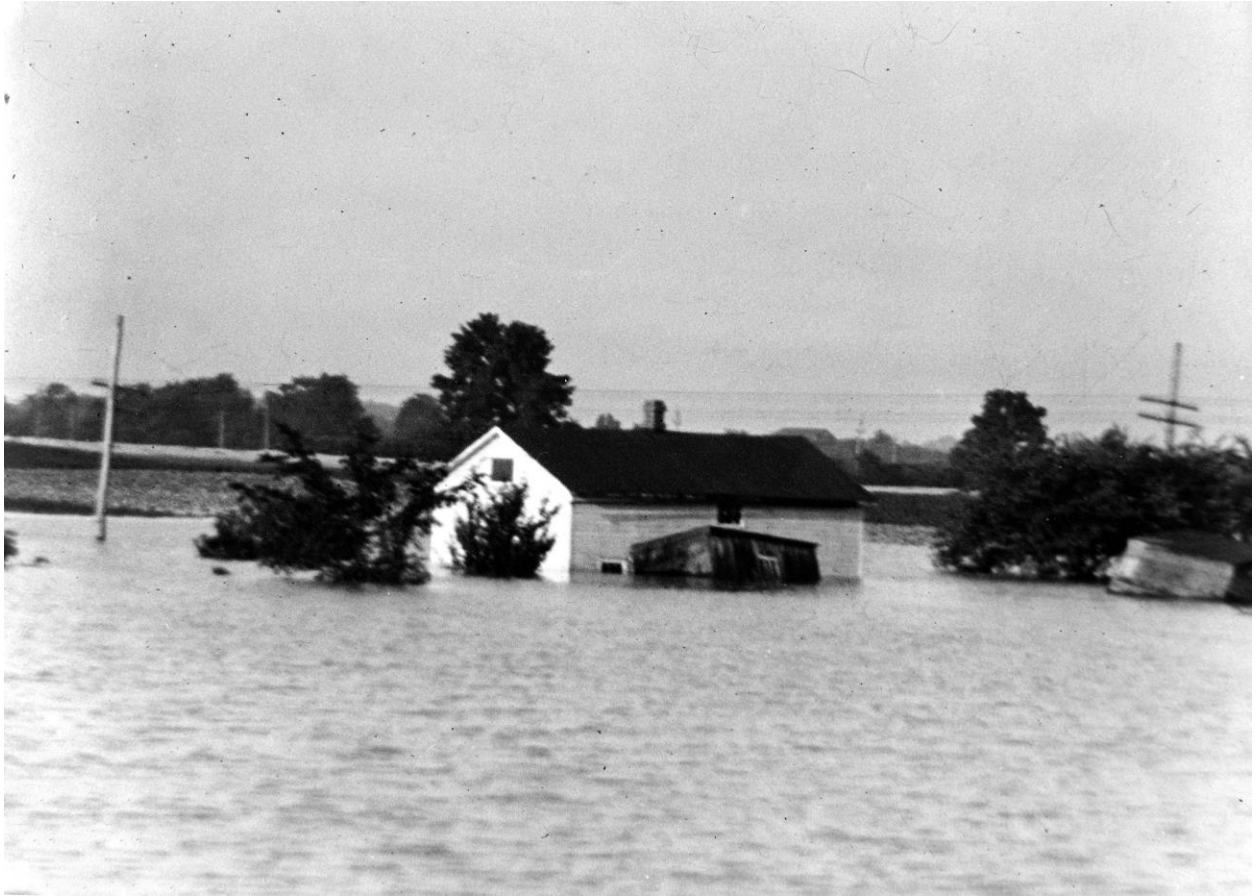
The success of the Erie Canal was not without trials and tribulations over its 200-year history. These photographs, taken in August of 1927, show the damage sustained during an extensive break in the canal wall near Eagle Harbor.

On August 3, 1927, local farmers observed a slight leak in the south wall of the canal near the Otter Creek gully. L. E. Bennett reported seeing a three-foot square hole open up, spilling thousands of gallons of water out of the waterway in a matter of minutes; the initial opening formed approximately 100 feet west of the Otter Creek culvert. Within a relatively short period of time, the flooring of the canal gave way and the south wall broke free, creating a hole that spanned 50 feet in length and 7 feet in height.

One of the photographs shows the submerged home of John Porter, who reported that his 1 acre crop of potatoes was submerged by 10 feet of water. Other farmers anticipated that their orchards would see the effects of long-term submersion over the next several years. Local potato, cabbage, tomato, cucumber, and grain crops were threatened by the extended flooding, but most feared that the potential for warmer weather would finish off any crops that managed to survive.

Canal Commissioner Thomas Farrell rushed to Albion shortly after the break was discovered to direct efforts to rebuild the collapsed wall. It was his impression that the repairs would be completed within ten days; however his more pessimistic colleagues anticipated a minimum of three weeks to finish the work. Albion officials pleaded with the State to keep the waterway open from the Lattin's Bridge Guard Gate (now Bowman's Bridge) through the eastern section of Orleans County.

Over 250 men were hired to work night and day in an effort to expedite the repairs. Over 20 trucks, 6 steam shovels, and other pieces of power equipment were utilized to hasten the project. Within two weeks the majority of work was complete, resulting in the laying off of 150 workers who were employed with the carpentry gang. Newspapers reported that state truck drivers were raising concerns about the use of unlicensed trucks and drivers to haul stone and materials on and off the job site. After all work was completed, the total damage was estimated at \$250,000 (\$3.5 million today) and residents impacted by the flooding were expected to bring lawsuits against the State for damages.

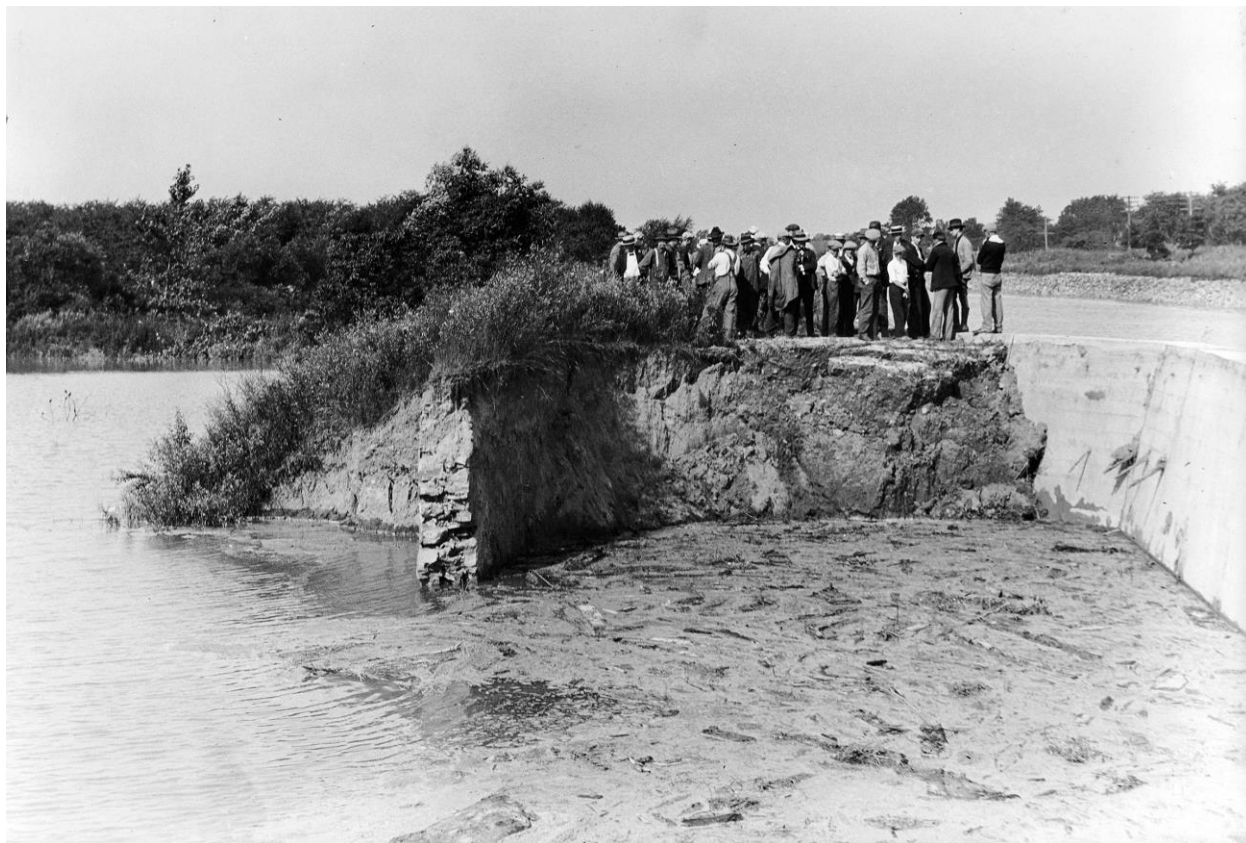
Photograph shows the cement wall over the collapsed culvert. The wall was undamaged when the floor and embankment gave way.
